TALLO LIKHU JALAVIDHYUT AAYOJANA (28.1 MW)

MONTHLY PROGRESS REPORT #48

APRIL, 2022 (18 Chaitra, 2078 to 17 Baisakh, 2079)

SWET GANGA HYDROPOWER & CONSTRUCTION LIMITED

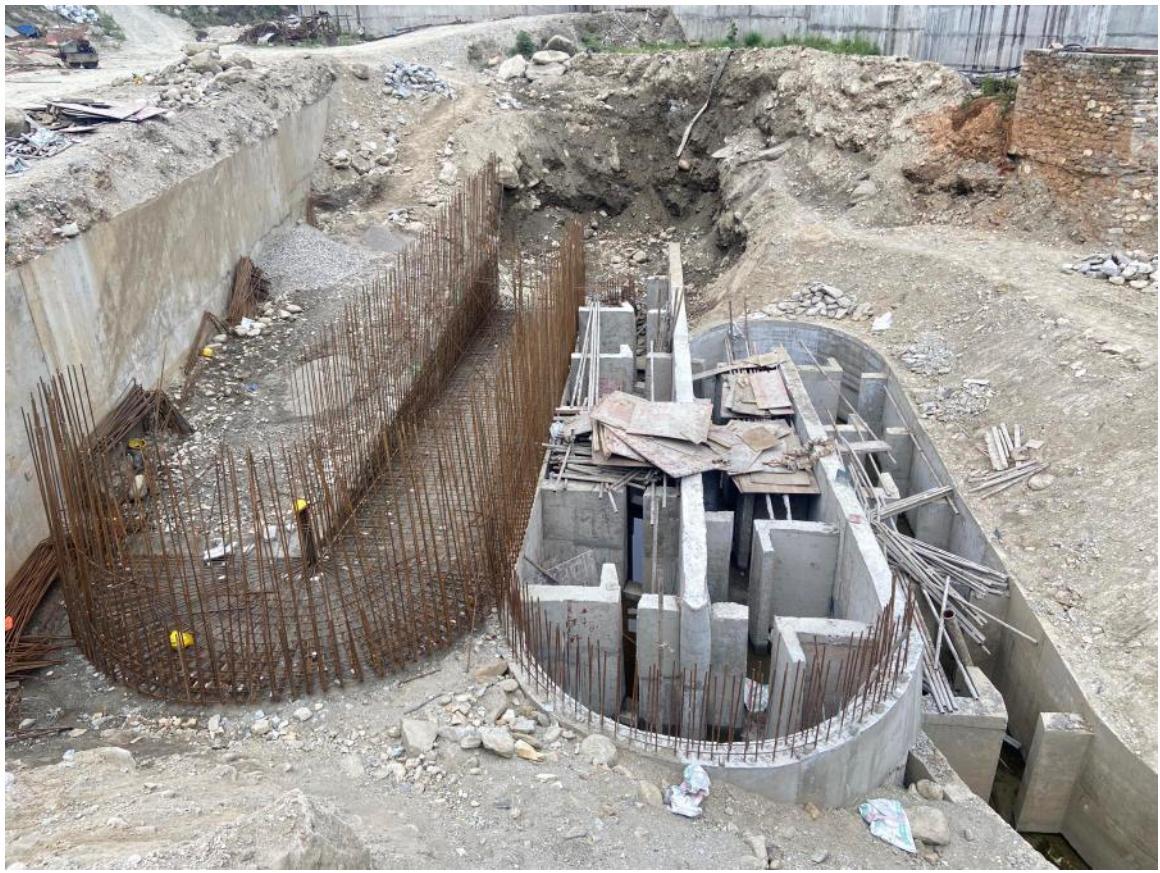
Figure 2: View of fish passage

- Construction of the stone masonry stair in the intake area has been completed.
- Concreting has been completed for 28 m stretch of the fish passage (chainage 0+087.00 m to 0+115 m). Reinforcement bar installation work is ongoing at the stretch between chainage 0+065 m to 0+087 m.
- Construction of the settling basin spillway has been completed along with the upstream and downstream wing walls.
- Construction of the box culvert crossing has been completed at the main inlet kholsi crossing. Also, the concrete casing for the headrace pipe section in the kholsi crossing has been completed.

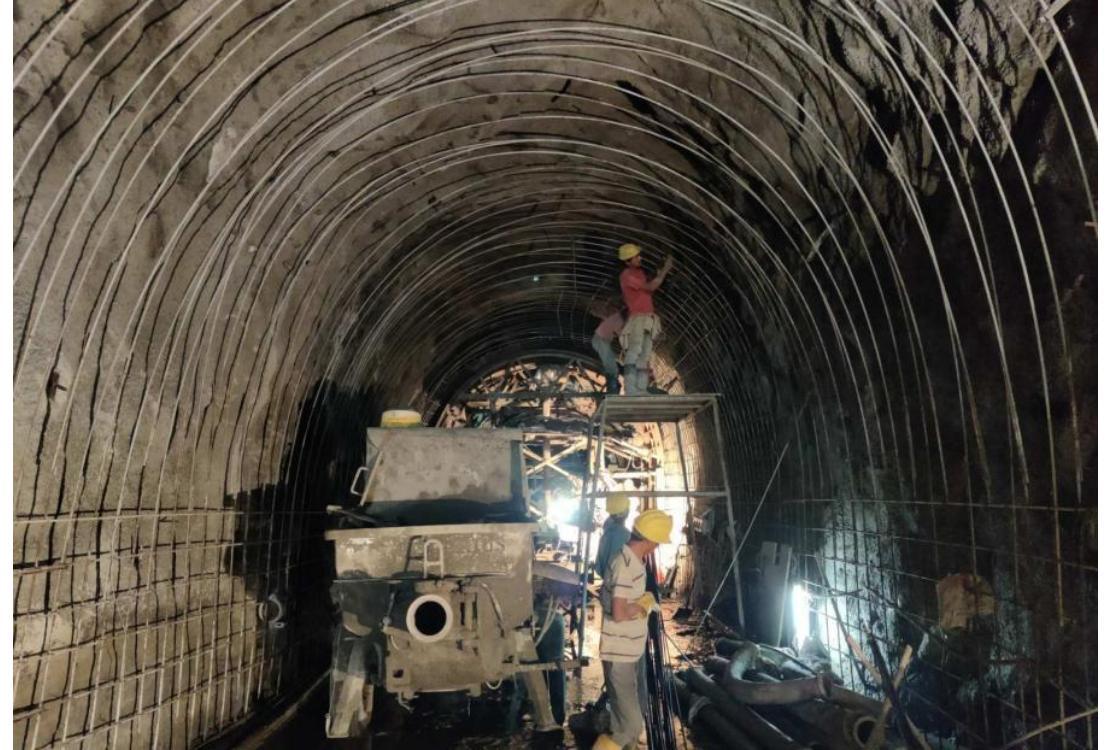
Figure 4: Reinforcement installation for concrete lining at the Seti Outlet tunnel

The full concrete lining work has been carried out for 155 m stretch in April 2022. (Total concrete lining completed = 806 m out of 865 m). The concrete lining works have been completed from the main inlet portal and pipe installation work is ongoing. The base concreting has been completed for the bell mouth area.

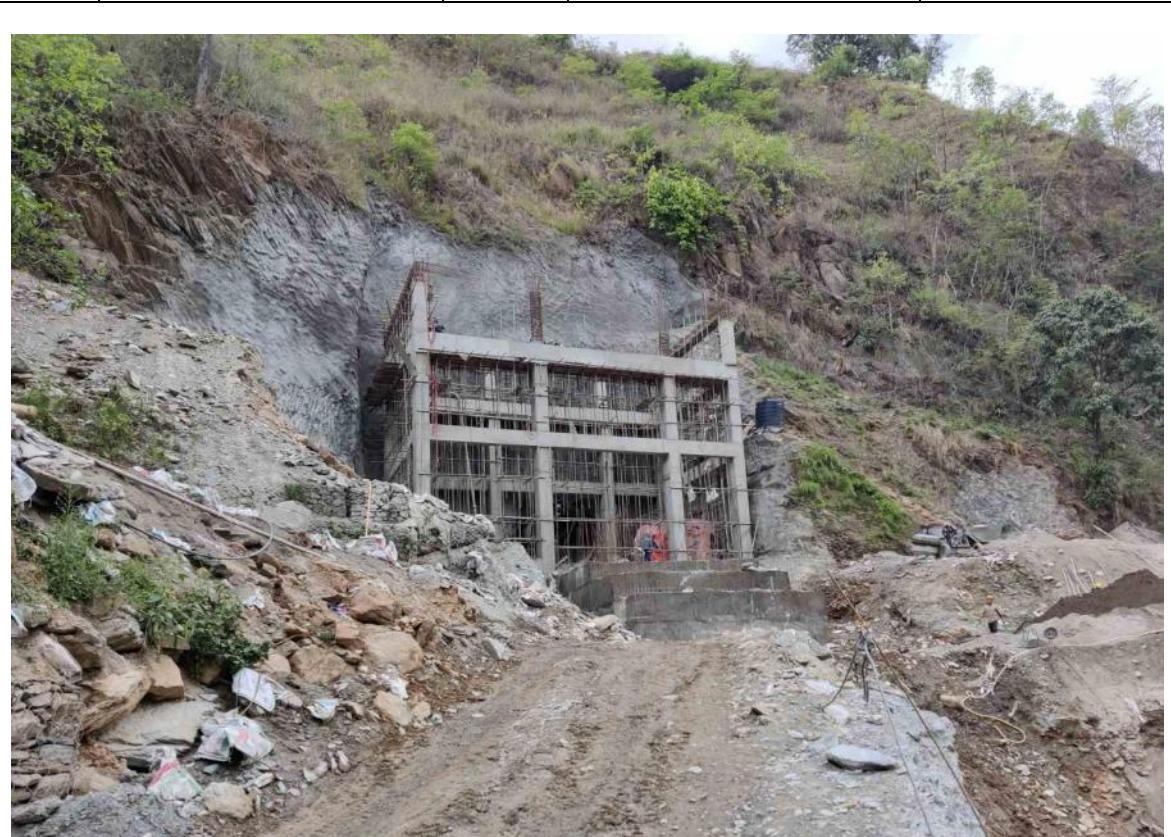
Figure 5: PPV house and anchor block VB01

Construction of the penstock protection valve house is ongoing. Anchor block VB01:

Plum concreting at the anchor block VB01 has been completed up to the invert of the pipe.

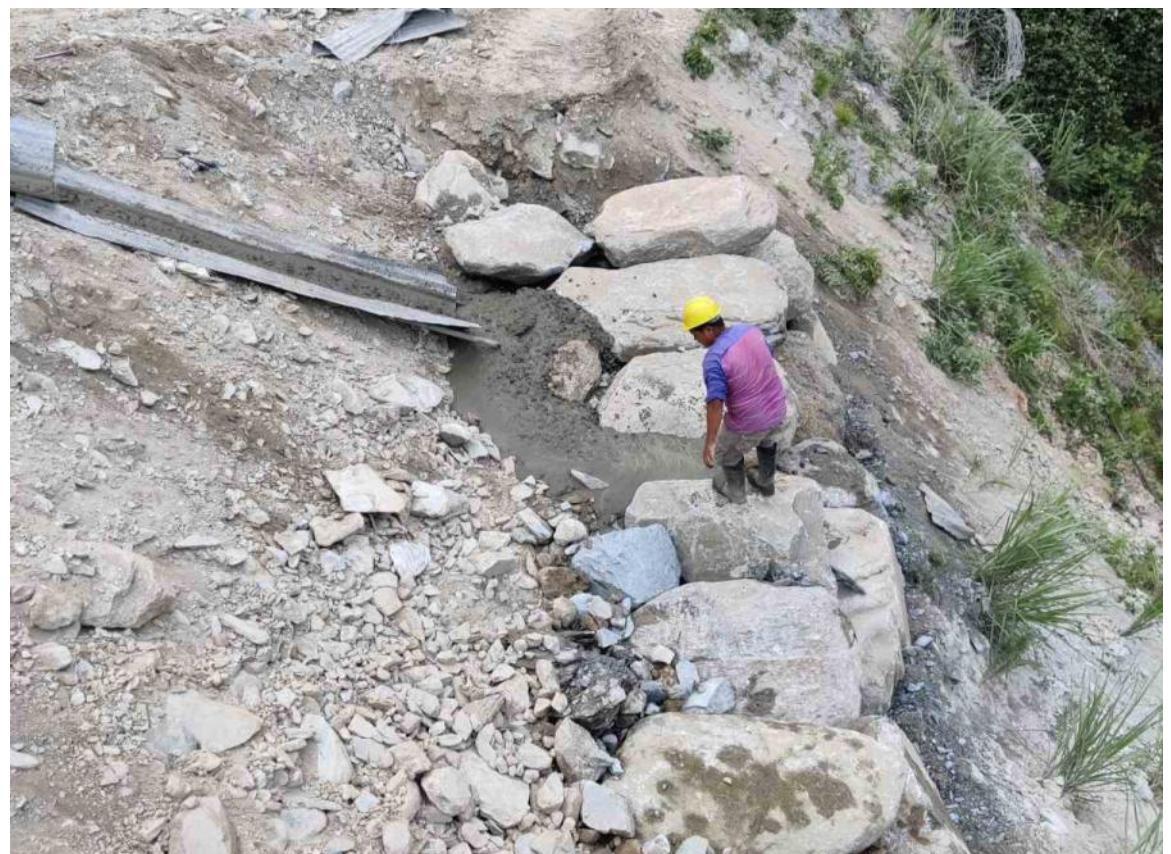
Figure 8: Boulder lining with concrete infill for the permanent access road at the left side of anchor block VB02

The geo-grid structure of road retaining wall at either sides of anchor block VB02 has been completed. Plum concreting works is going.**POWERHOUSE**:

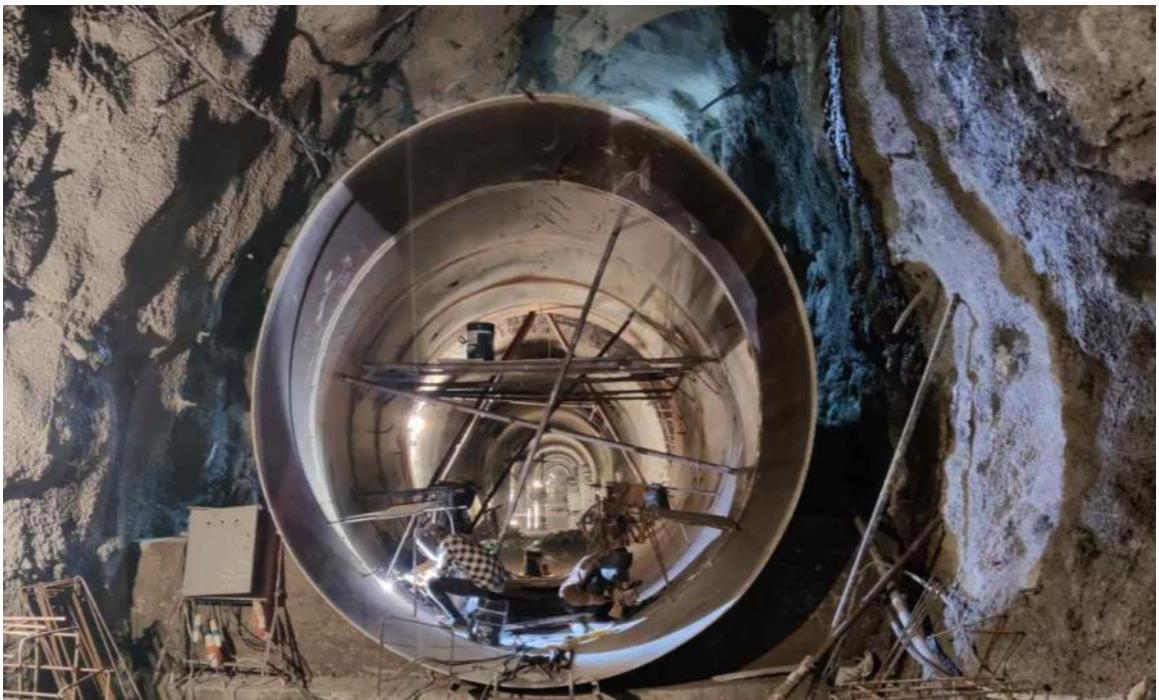
Figure 10: Installation of bell mouth at the main inlet portal tunnel

- Erection of bell mouth has been completed at the main inlet portal tunnel side.
- Installation of railings is ongoing in the settling basin and intake area.
- Testing of radial gate hoist is ongoing.
- The undersluice stoplog leaf has been shifted to the left bay using the lifting beam.
- Installation of fine trash-rack is ongoing in the conveyance tank.

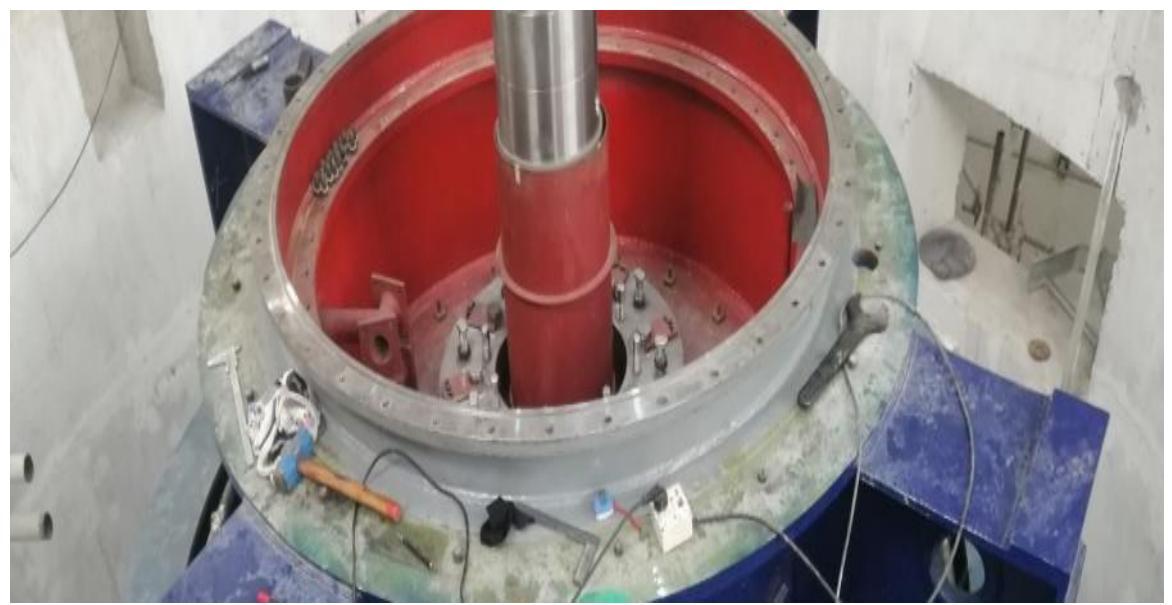
Figure 14: Final installation of Stator, rotor and upper bracket at unit 2

- Runner-shaft assembly, rotor and upper bracket have been lowered inside unit 2.
- Connection of cable and insulation painting work is ongoing.
- Installation of firefighting pipe and cooling pipe is ongoing.
- Installation of cable tray has been completed.

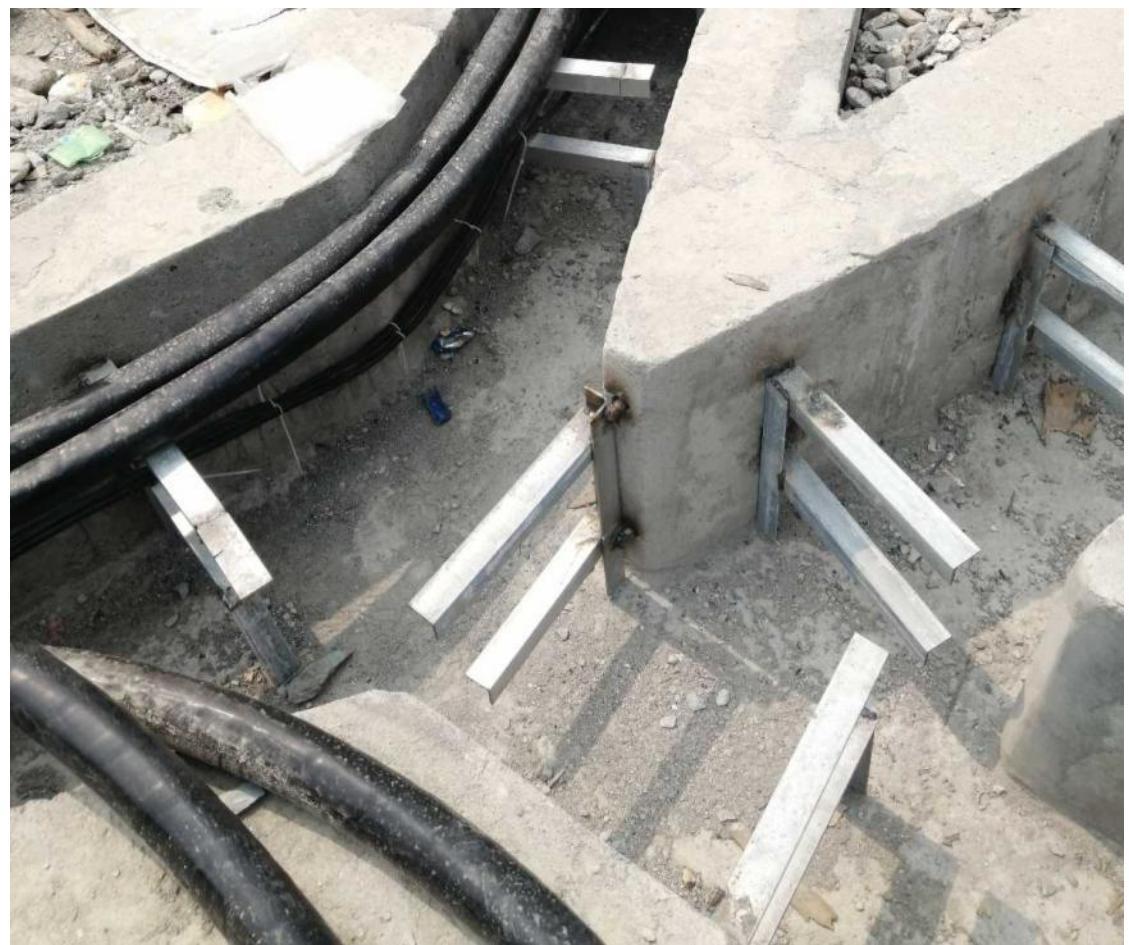
Figure 16: Cable laying from control room to switchyard

- Installation of main equipment has been completed except installation of isolation transformer and termination works.
- Filling of filtered transformer oil has been completed in both transformers.
- Installation of lighting tower has been completed.
- High voltage, low voltage and neutral bushing of the transformers have been installed.
- High voltage cable and control cable laying from control room to switchyard has been completed.

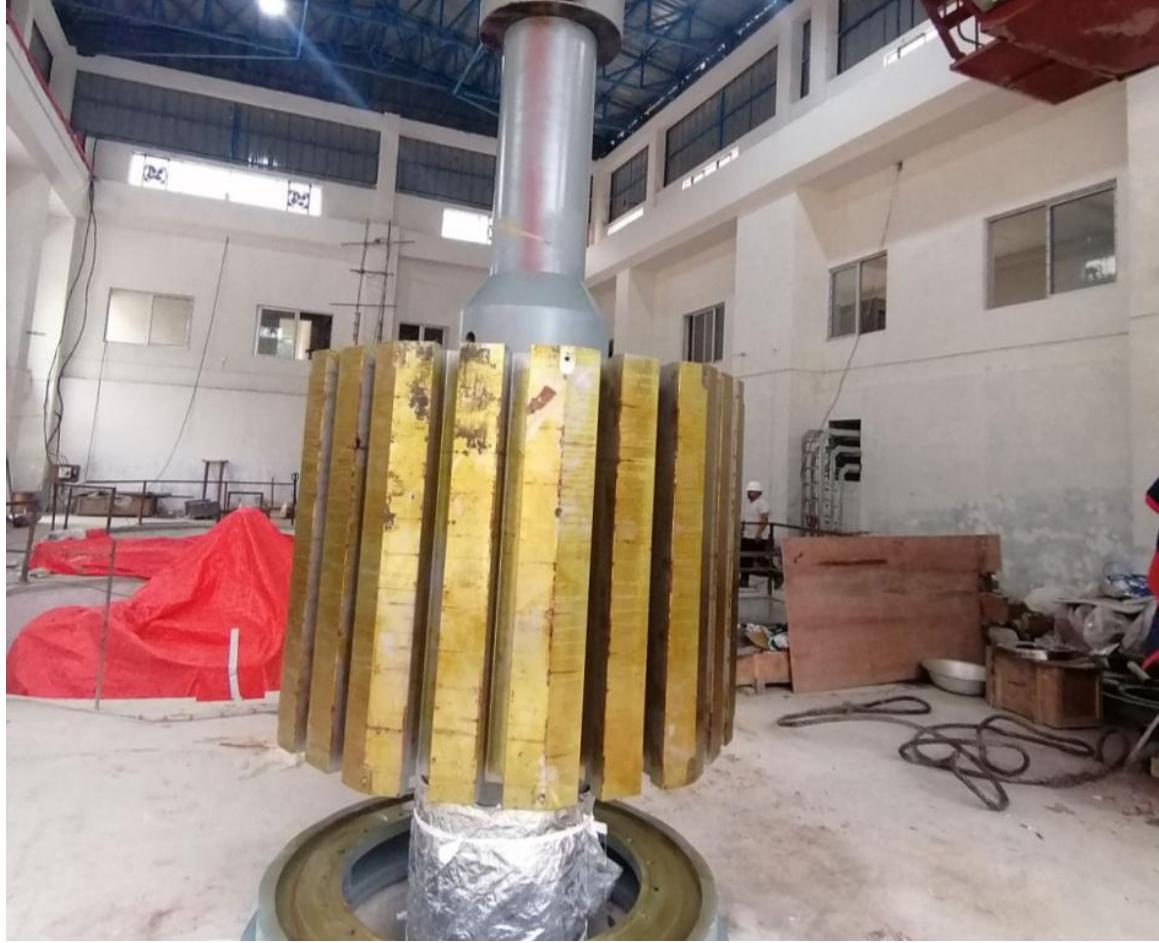
Figure 18: Rotor pole erection works for unit 1

- Rotor-pole assembly is ongoing.
- Installation of cable tray has been completed.

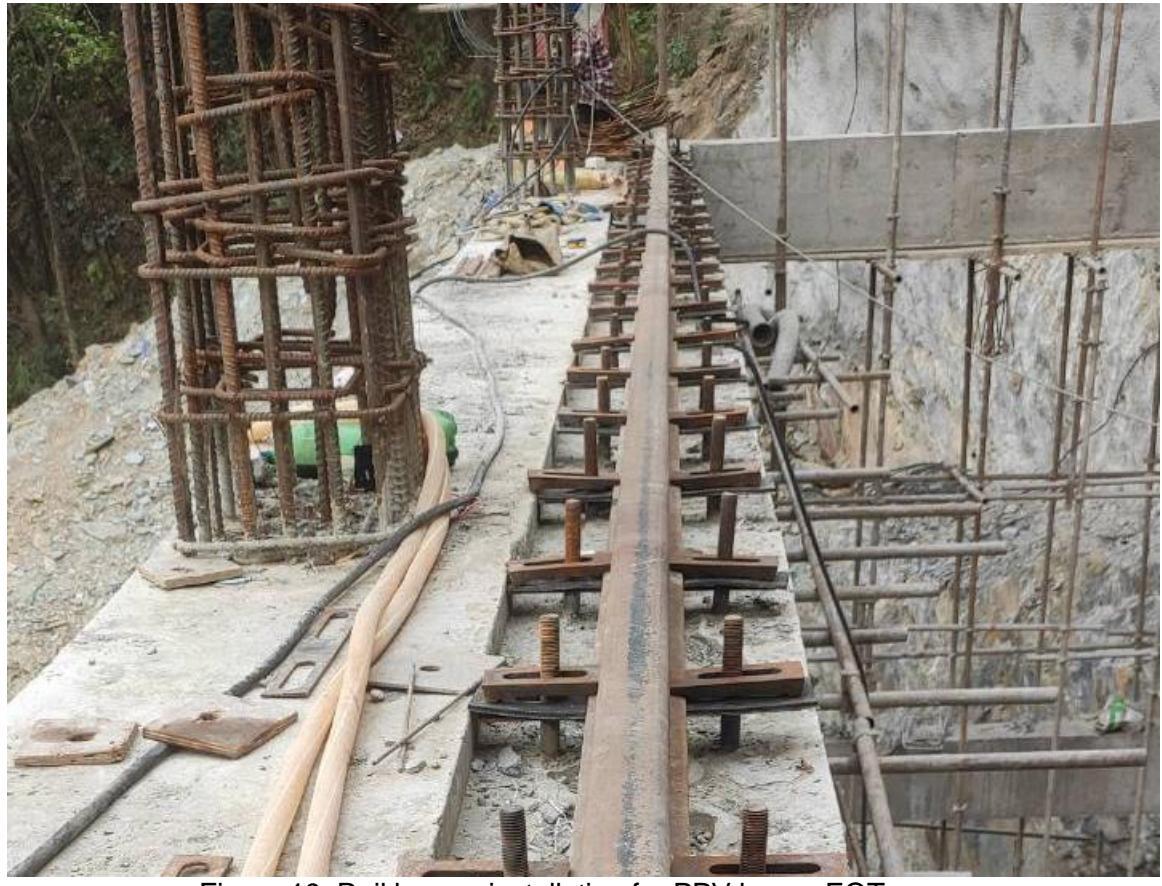
Figure 19: Rail league installation for PPV house EOT crane

• Installation of rail leagues for EOT crane has been completed.

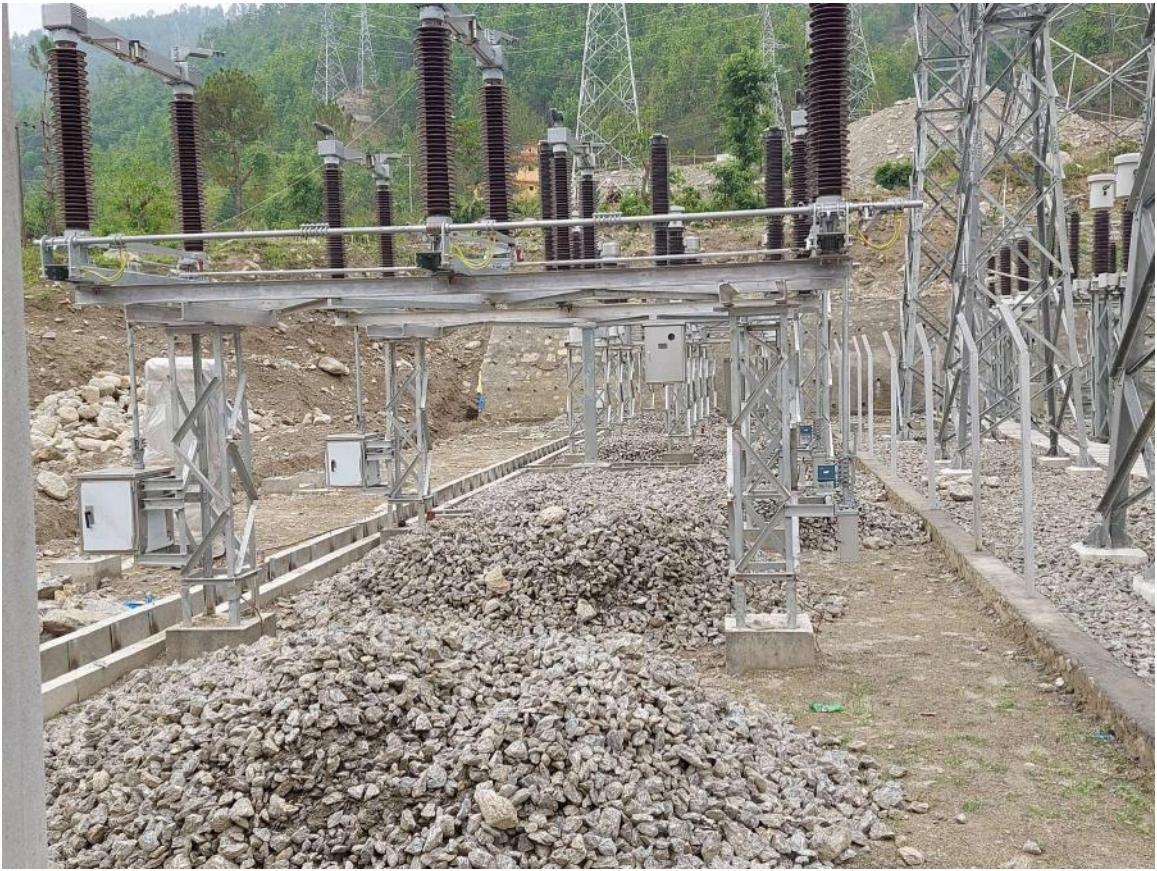
Figure 20: Aggregate laying in the New Khimti substation bay

- Installation of main substation equipment and metering equipment has been completed.
- Transmission line protection panel has been installed inside the control room.
- Gravel laying work is ongoing.

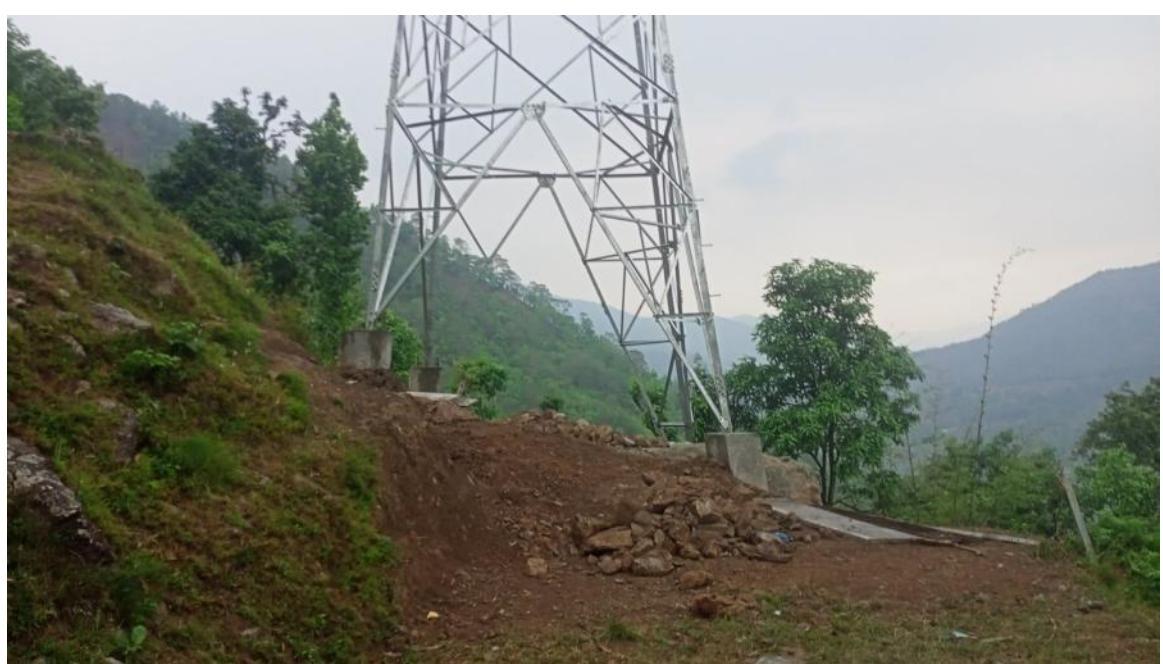
Figure 21: Erection of AP58

In April 2022, erection of two towers (AP38 and AP58) has been completed. With this, the erection works have been completed for 60 towers. The concreting works have been completed for 61 tower foundations. Conductor stinging works have been completed for 19.781 km stretch and OPGW cable has been installed for 15.329 km.
